Arboricultural Report

Hill Street, Boddington

25th March 2021

Prepared for:
Jeff Atkins
Shire of Boddington

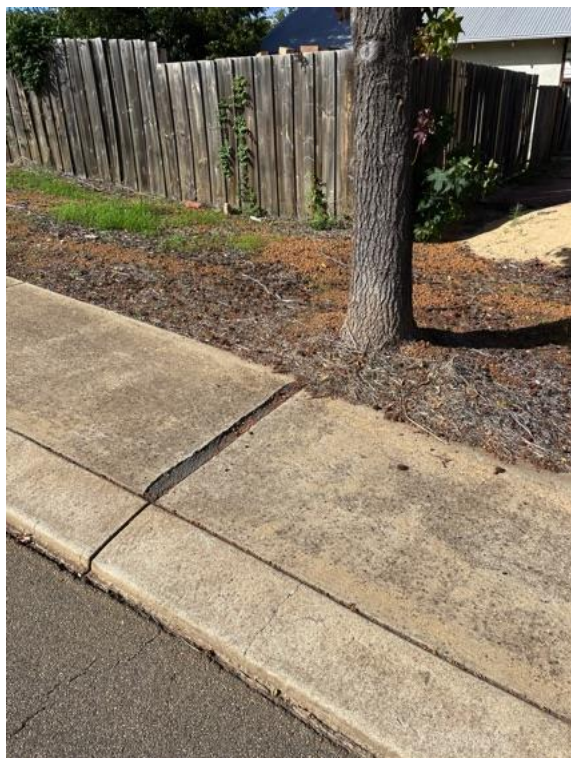
Figure 3 - Tree 1 planting location

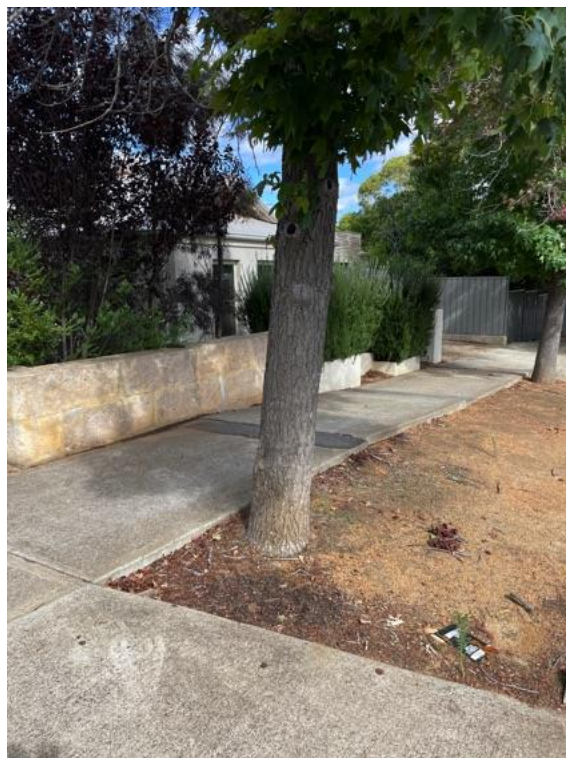
Figure 4 - Planting location typical of trees 2-11

The trees are in such close proximity to the footpath that there is no alternative space for the for the roots to grow. The interface between the concrete of the footpath and the base underneath can be a source of increased moisture from condensation build-up as the temperature of different materials changes at different rates. This in turn can promote increased root growth rate underneath the footpath and retaining wall, both lateral elongation and radial expansion. The radial increase in root diameter cannot be easily absorbed by compression of previously compacted base below the footpath but is instead directed upward, lifting and cracking the concrete panel.

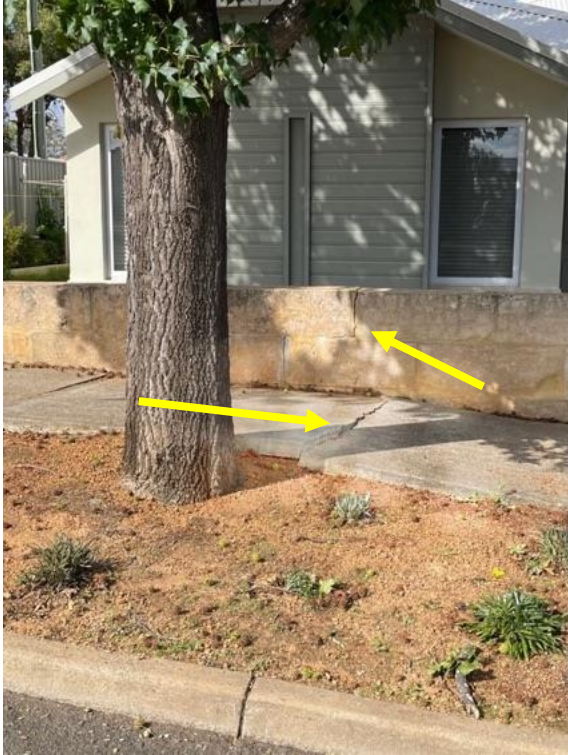
Figure 5 - Tree 2 Cracked lifted footpath, cracked wall

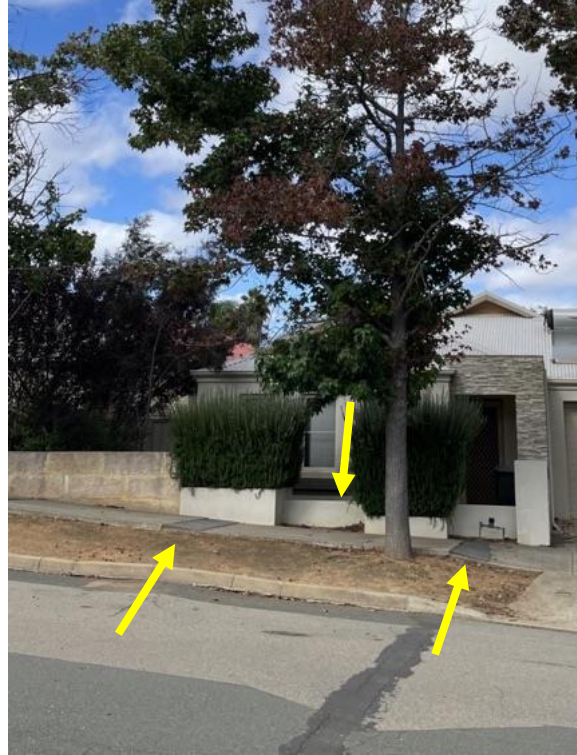
Figure 6 - Lifted and repaired footpath, cracked wall

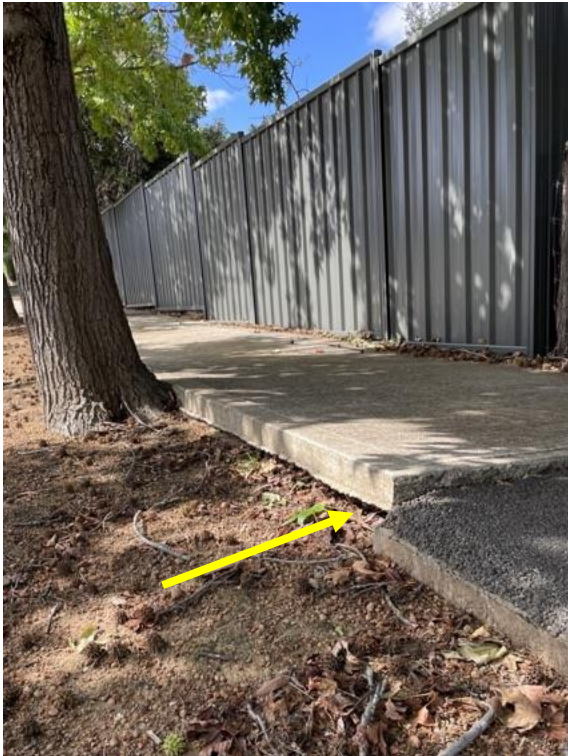
Figure 7 - Tree 9 Lifted footpath

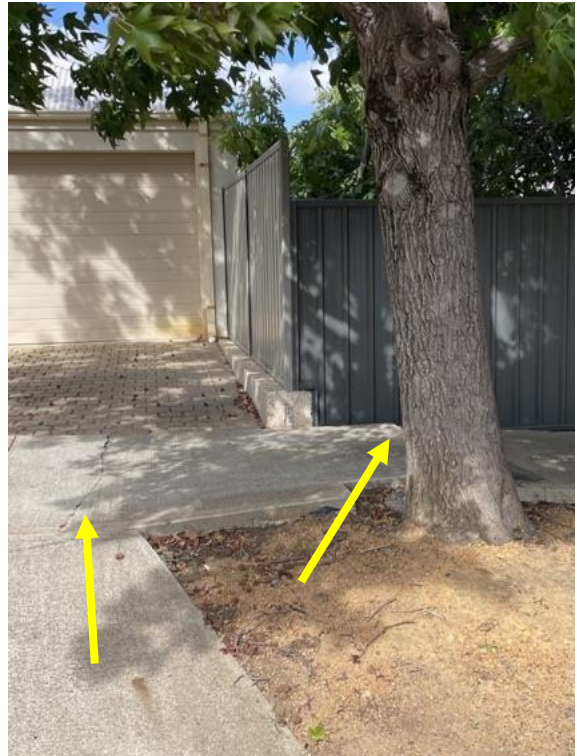
Figure 8 - Tree 7 Cracked and lifted foot path, uneven driveway

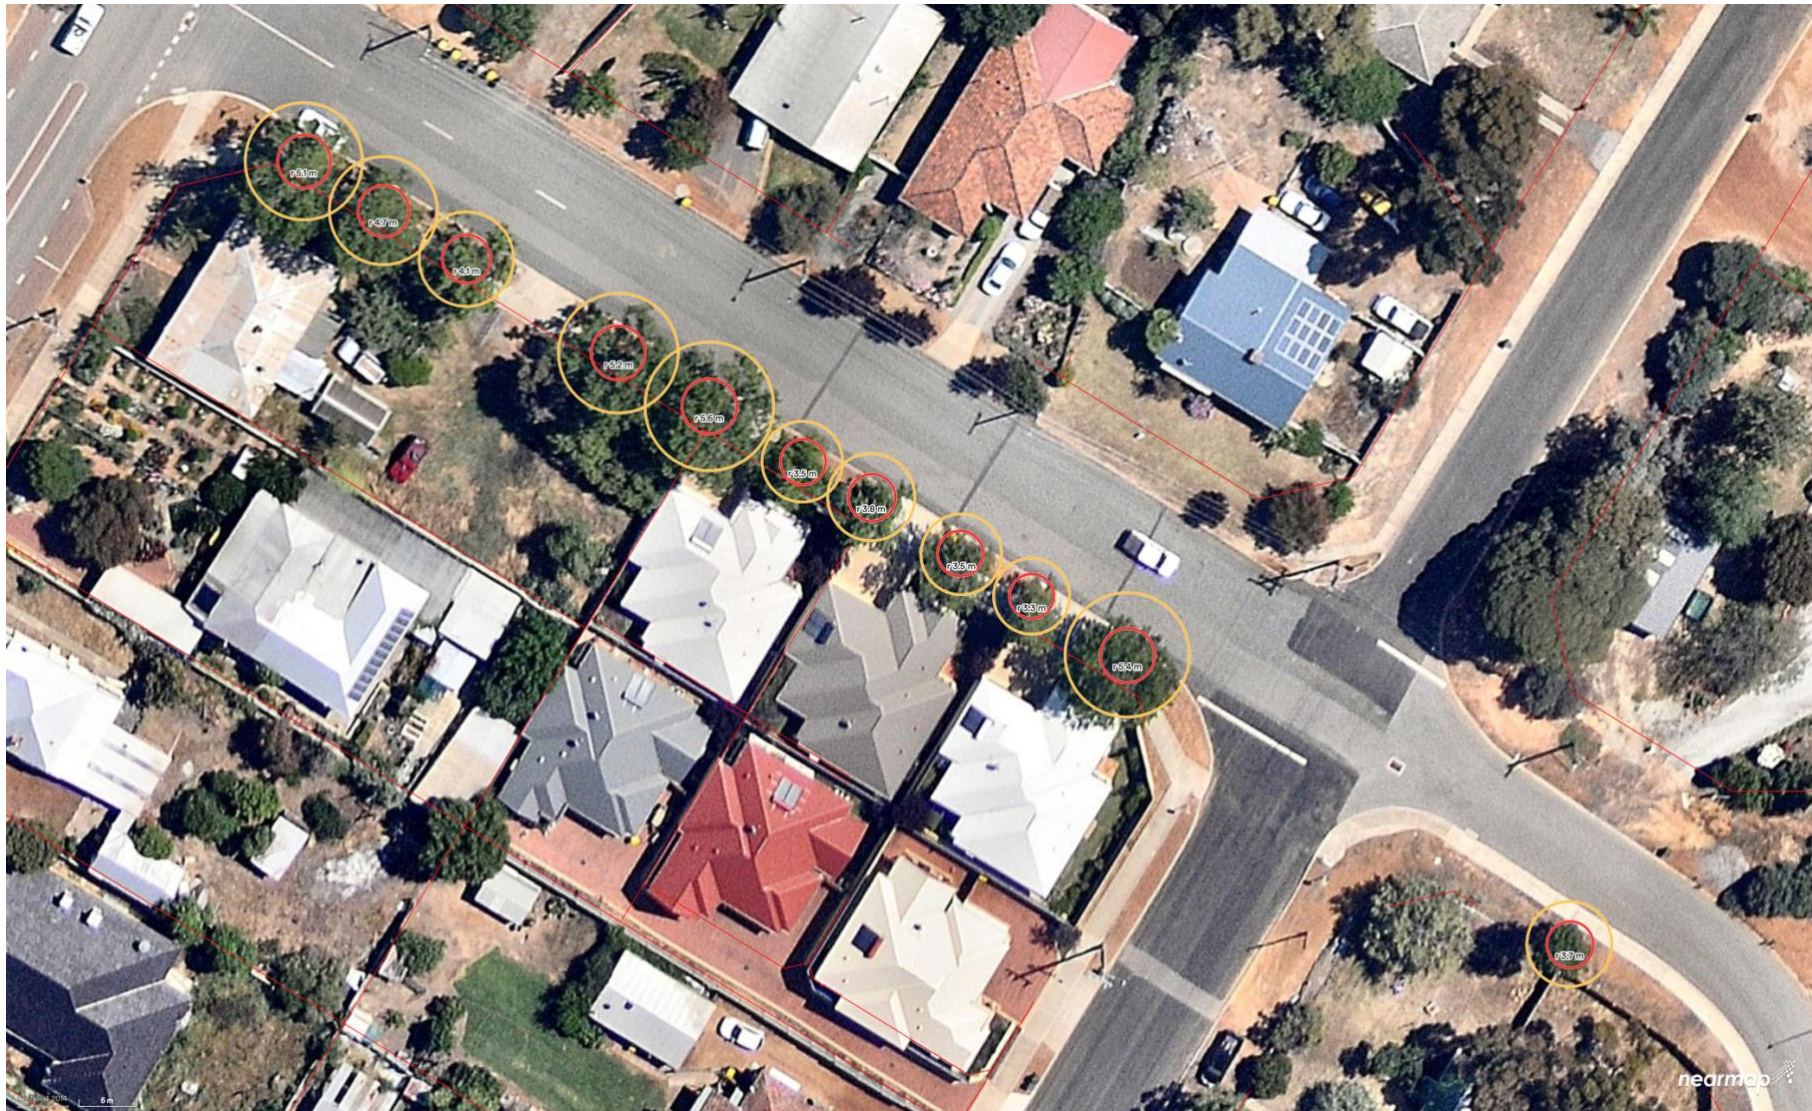
It is important to note that for all trees the minimum required area for the protection of structural roots extends beyond both the footpath and the property boundary. Any work to mitigate current damage or future damage will compromise the structural integrity of these trees.

Figure 10 Showing TPZ (yellow) and SRZ (red). Figures are radius of TPZ in meters
