Friends of the Reserve - Boddington (Inc.): Ranford Pool (Darminning Pool) Restoration

Figure 1 - Proposed Layout

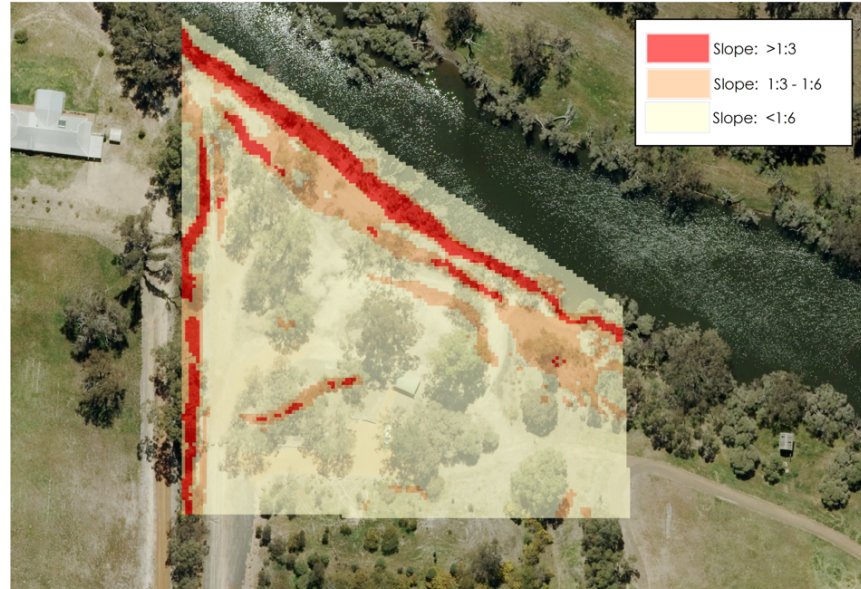
12. Beach Area - Stabilisation of the beach area is required to prevent further erosion. Rocks should be installed along the edge of the river bank and along the edge of the revegetation work to provide some protection during higher flow events. For aesthetics and access, logs are to be installed to create steps down to the water edge. The existing terrace and pathway in front of the observation area will be retained and reinforced with logs and backfilling. Trees immediately to the west of the beach area are vulnerable to collapse due to existing erosion concerns. If they collapse into the pool, they should be removed from the beach area and used as woody debris elsewhere along the bank.
