# BODDINGTON FLOODPLAIN MANAGEMENT STUDY

## Designated Floodway and Levels 100 Year ARI Flood Mapping Series Map 4

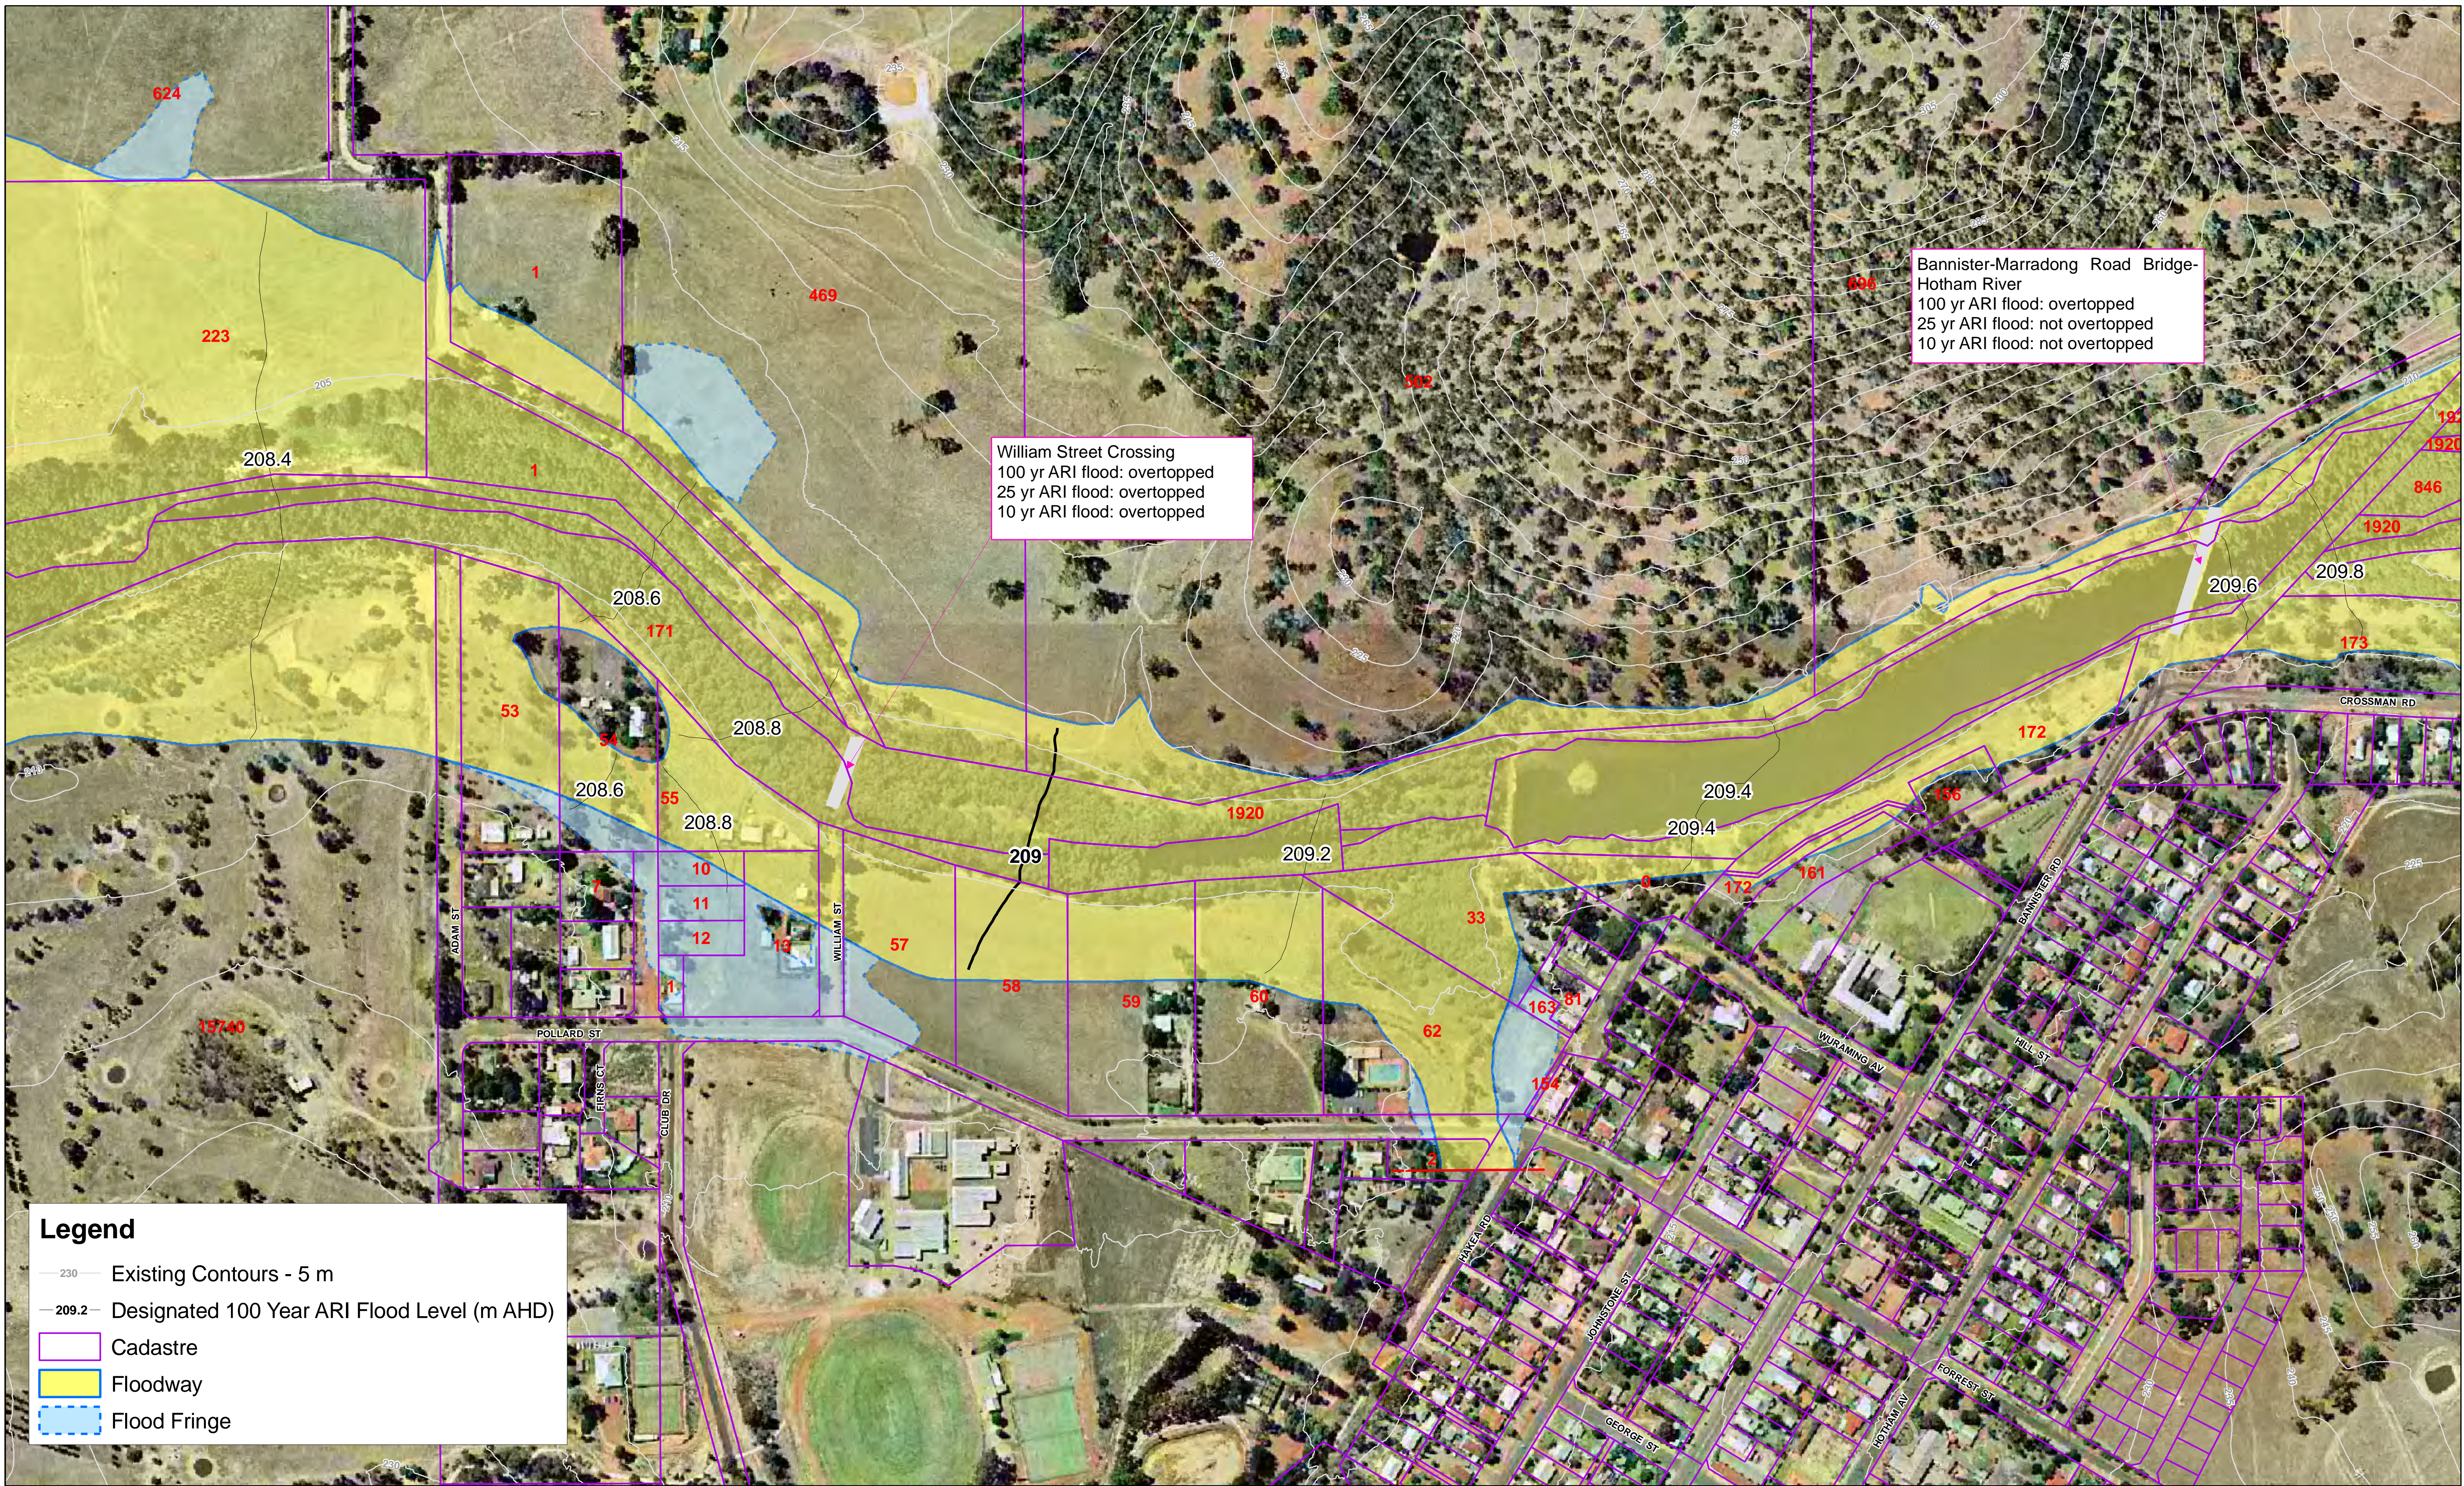
Bannister-Marradong Road Bridge-  
Hotham River  
100 yr ARI flood: overtopped  
25 yr ARI flood: not overtopped  
10 yr ARI flood: not overtopped

William Street Crossing  
100 yr ARI flood: overtopped  
25 yr ARI flood: overtopped  
10 yr ARI flood: overtopped
